# 805 Home Inspections

## Property Inspection Report

Dream Home with a Pool, Tarzana, CA  
Inspection prepared for: John Doe  
Real Estate Agent: More Sales - Realtor

Date of Inspection: 11/14/2017

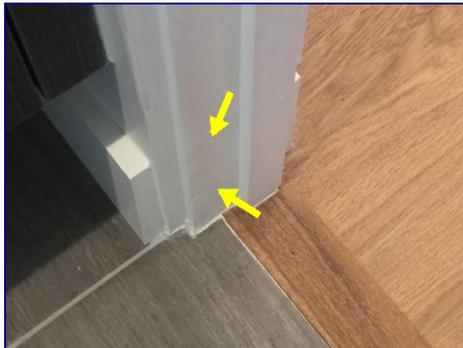
- **The front Southeast bedroom's bathroom door rubs on the door frame.**

The front Southeast bedroom's bathroom door rubs on the door frame.

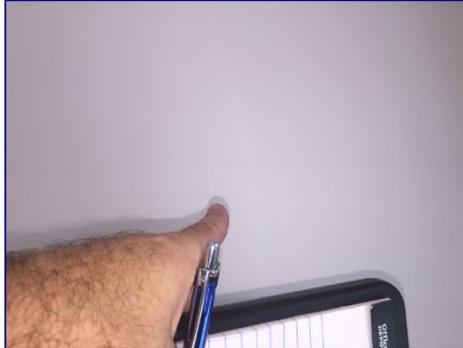
- There is a small hairline crack in the drywall outside the Master bedroom.

There is a small hairline crack in the drywall outside the Master bedroom.

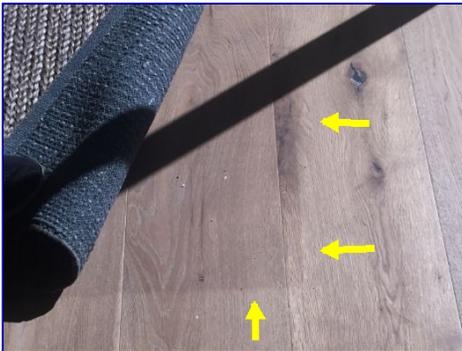
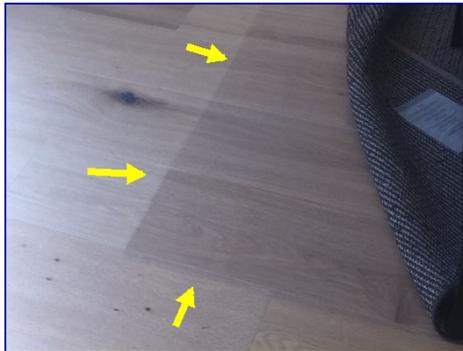
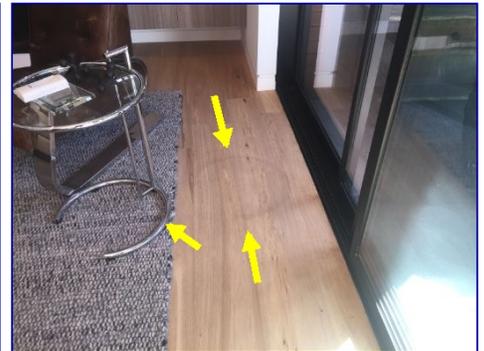
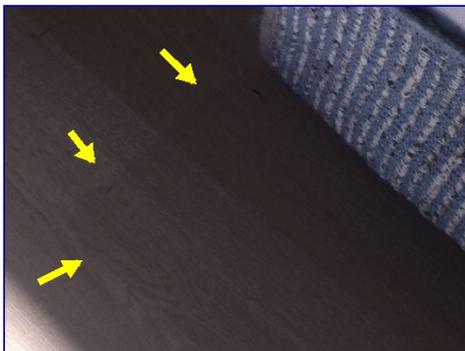
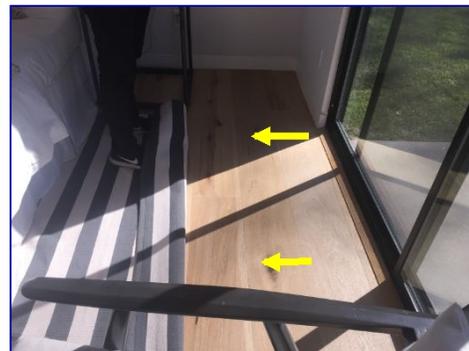
- The interior wood flooring has been discolored by the sun in several areas throughout the home.

The interior wood flooring has been discolored by the sun in several areas throughout the home.

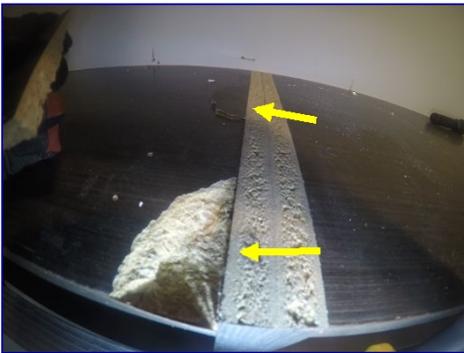
The Southwest bedroom closet cabinet was damaged access, prior to our inspection.

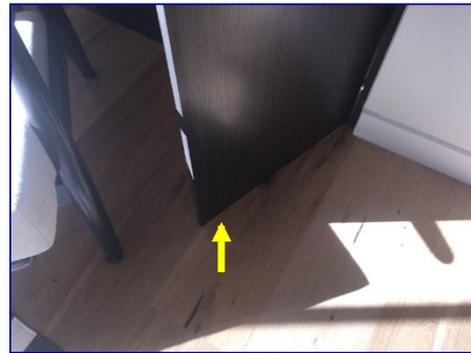
The Southwest bedroom closet door is too low to the ground and rubs the floor.

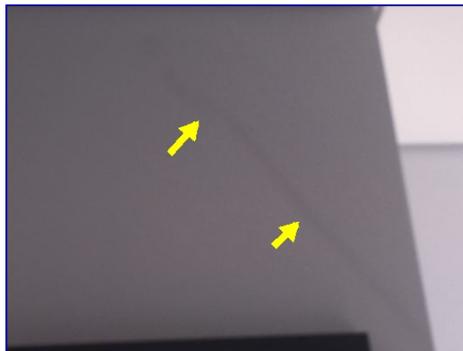
- The Master bedroom has a visible repaired drywall crack over the gas fireplace furnace.

The Master bedroom has a visible repaired drywall crack over the gas fireplace furnace.

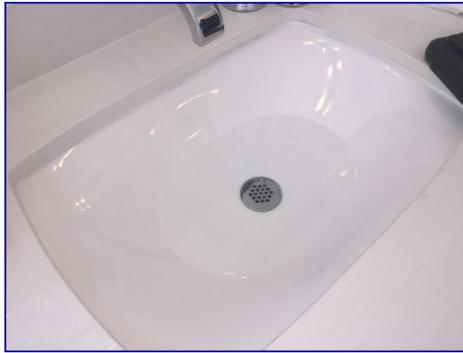
- **The Master bathroom sinks are clogged and drain slowly.**

The Master bathroom sinks are clogged and drain slowly.

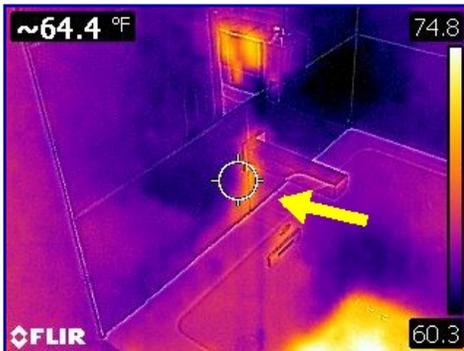
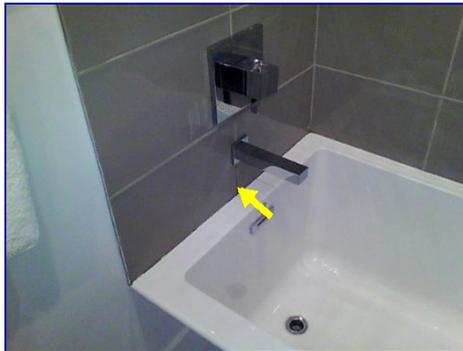
- **The North side bathroom tub has a water leak at the water spout, inside the wall.**

The North side bathroom tub has a water leak at the water spout, inside the wall.

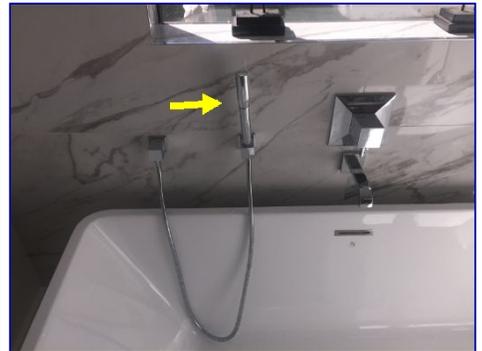
The Master bathtub has a hand wand that will spray water all over the floor if not used correctly.

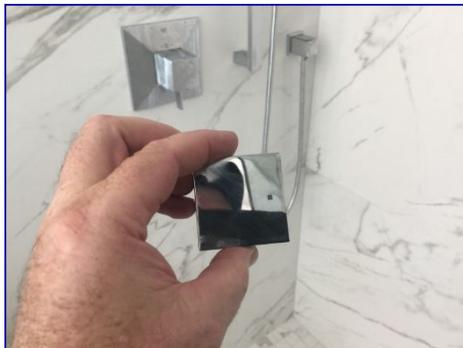
- **The Master bathroom shower faucet handle came off and needs to be reinstalled.**

The Master bathroom shower faucet handle came off and needs to be reinstalled.

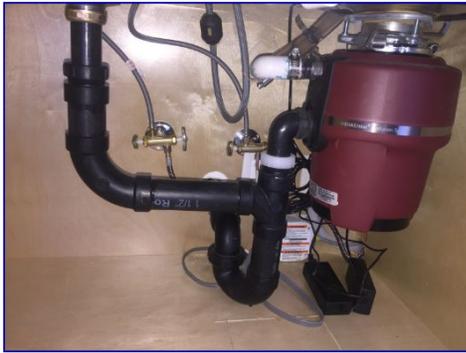
The kitchen garbage disposal did not function properly when tested.

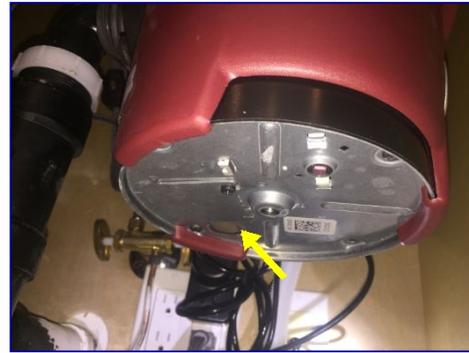
- **The kitchen garbage disposal was not wired to the homes electrical system.**

The kitchen garbage disposal was not wired to the homes electrical system.

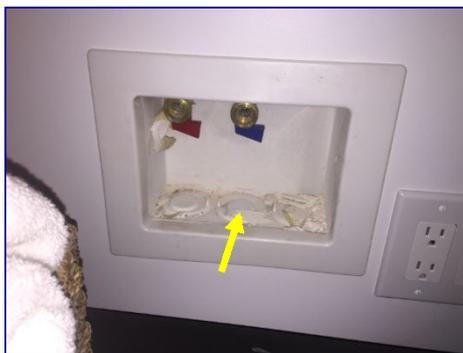
- **The laundry room sewer drain is still capped for the clothes washer.**

The laundry room sewer drain is still capped for the clothes washer.

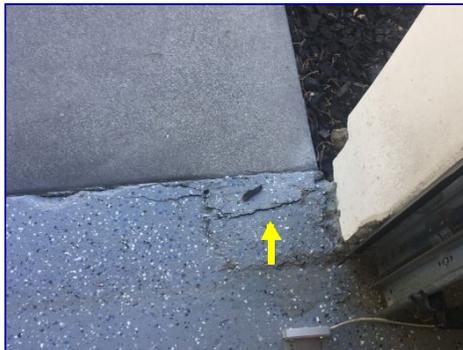
- There is a crack in the cement flooring at the front of the garage.

There is a crack in the cement flooring at the front of the garage.

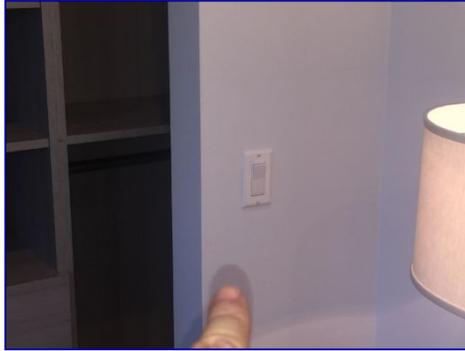
- The North side bedroom has a wall switch that did not operate anything. The switch is outside the closet.

The North side bedroom has a wall switch that did not operate anything. The switch is outside the closet.

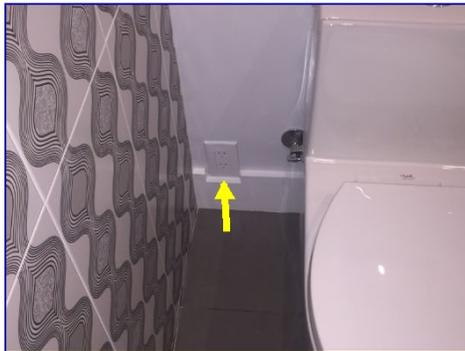
- All the home's bathrooms have an electrical receptacle mounted under the left side of the toilets. None of the receptacles are GFCI protected.

All the home's bathrooms have an electrical receptacle mounted under the left side of the toilets. None of the receptacles are GFCI protected.

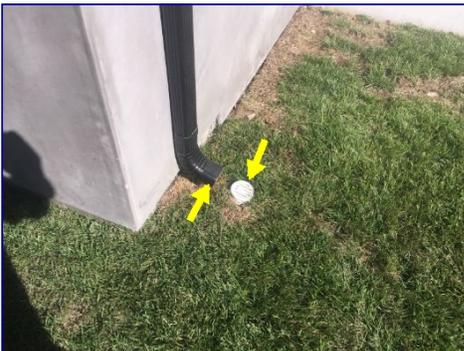
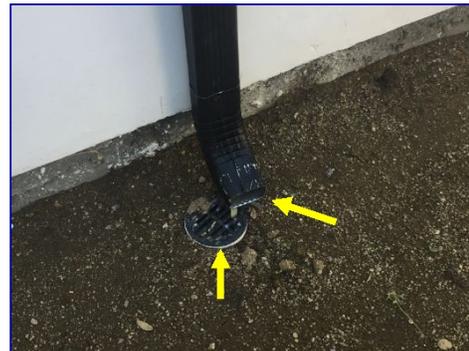
- **The rain gutter down spouts do not line up with the ground drains.**

The rain gutter down spouts do not line up with the ground drains.

The exterior rain gutter down spout are not lined up with the ground drains.

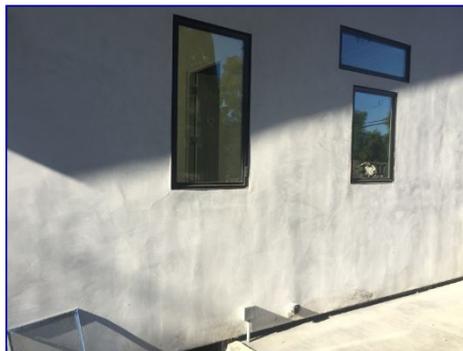
- The South side exterior stucco wall has several small hairline surface cracks that should be monitored for change.

The South side exterior stucco wall has several small hairline surface cracks that should be monitored for change.

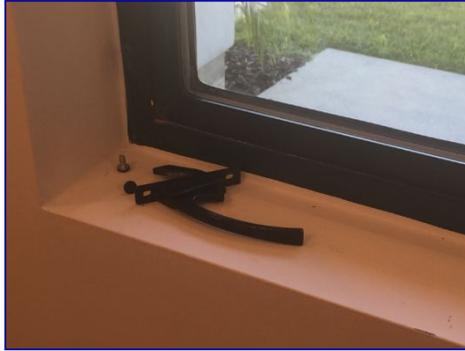
- The front Southeast side bedroom window has an uninstalled window latch.
- The home window screens were all missing at the time of the inspection.

The front Southeast side bedroom window has an uninstalled window latch.

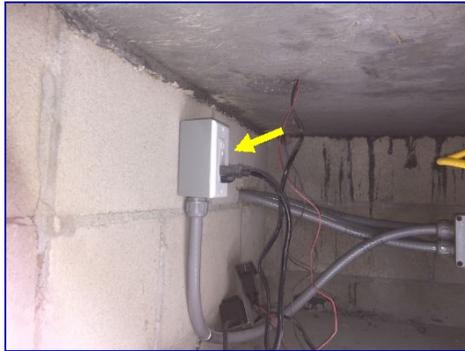
- The electrical receptacle under the BBQ grill is not GFCI protected.

The electrical receptacle under the BBQ grill is not GFCI protected.

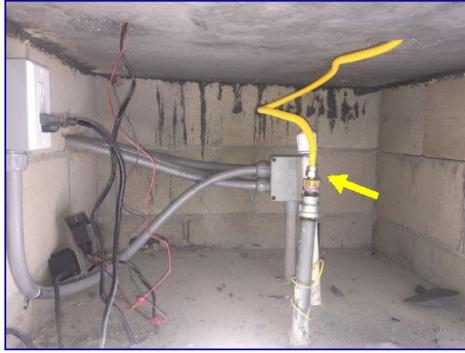
- **The backyard gas BBQ grill gas line has no shutoff valve.**

The backyard gas BBQ grill gas line has no shutoff valve.

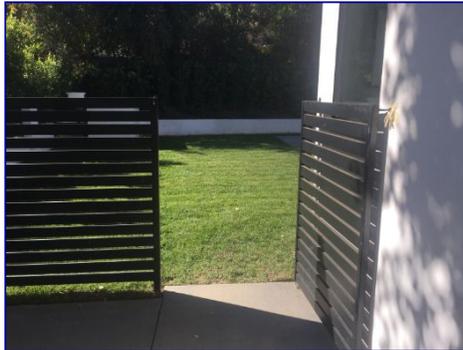
- The South side metal pool gate does not close automatically. The spring is worn out

The South side metal pool gate does not close automatically. The spring is worn out.

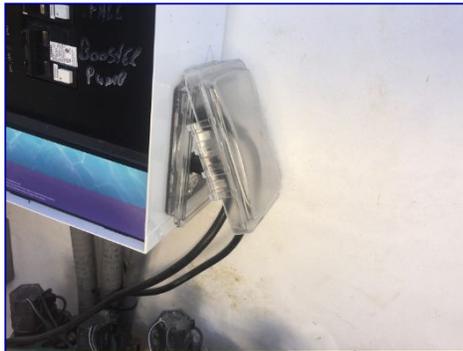
- The pool pump electrical receptacle needs a bubble top cover to support cords being plugged in full time.

The pool pump electrical receptacle needs a bubble top cover to support cords being plugged in full time.

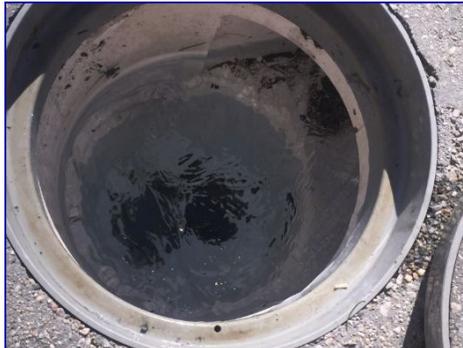
- **The pool water skimmer is missing a debris basket.**

The pool water skimmer is missing a debris basket.

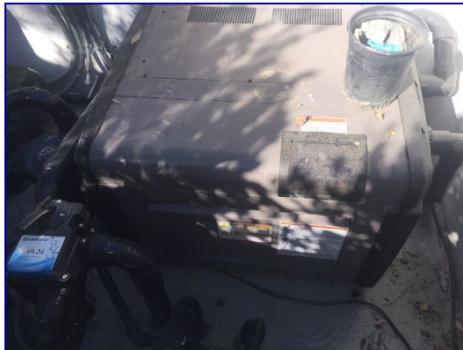
- **The pool heater did not functional at time of inspection. Ask seller to prove proper pool heater function, prior to close.**

The pool gas heater did not light at the time of the inspection. Confirm its proper operation prior to close.

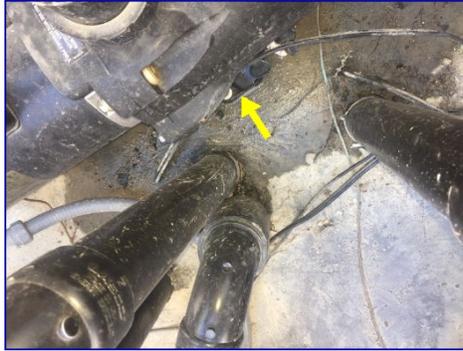
- **The waterfall pool pump is leaking water from the two side relief valves.**

The water fall pool pump is leaking water from the relief valves.

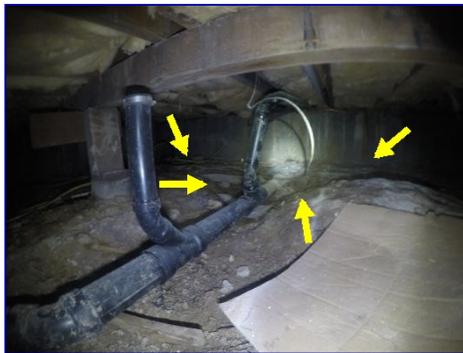
- The ground in the crawlspace under the kitchen area is damp along the sewer pipe. There was no active leak observed at the time of the inspection.

The ground in the crawlspace under the kitchen area is damp along the sewer pipe. There was no active leak observed at the time of the inspection.

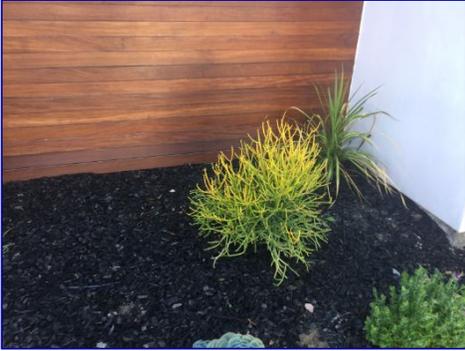
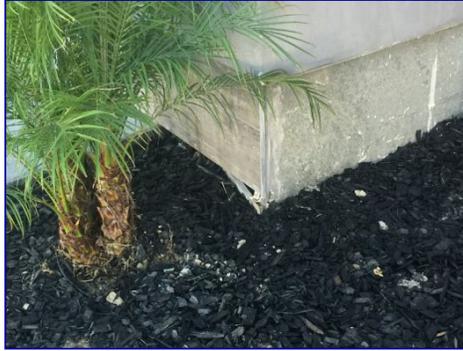
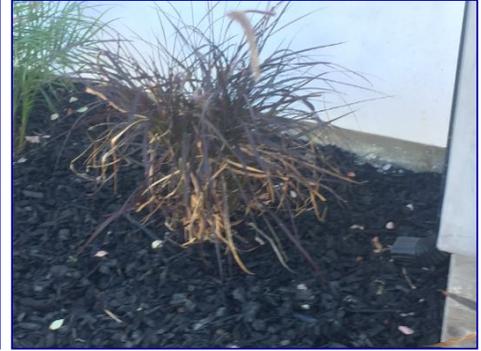
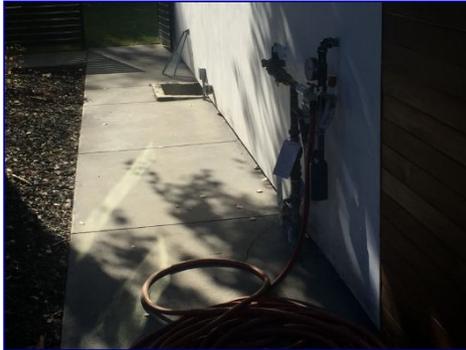
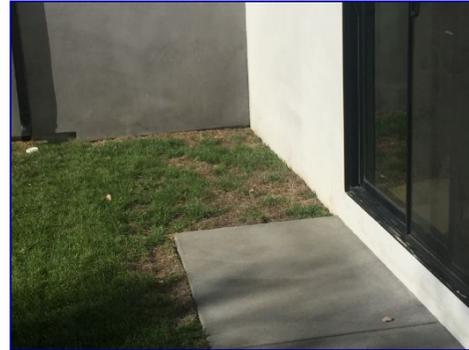
- The crawlspace had no ventilation installed at the time of the inspection. I confirmed verbally with the City of LA's residential building department that vents are required to be installed all along the outer walls of a raised foundation. The lack of vents installed in this home is a defect that does not meet requirements and should be corrected.

The exterior crawlspace of the home has no installed vents along the footings.
