# 805 Home Inspections

## Property Inspection Report

Manufactured Home, CA  
Inspection prepared for: John Doe  
Real Estate Agent: More Sales - Realtor

Date of Inspection: 9/2/2017

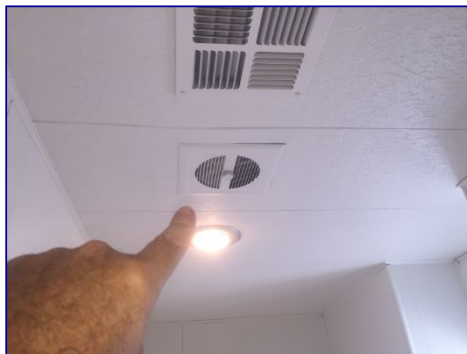
- **The Master bath fan is noisy and may be at the end of its useful life.**

The Master bathroom exhaust fan is noisy.

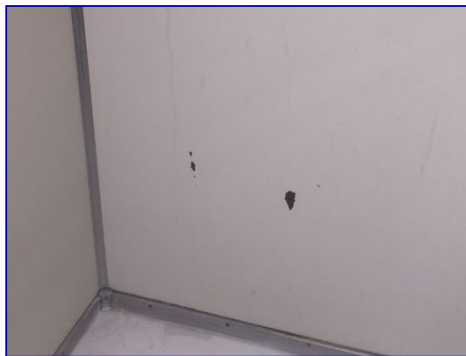
The shared bathroom tub surround is a paneling with aluminum trim. Suggest sealing.

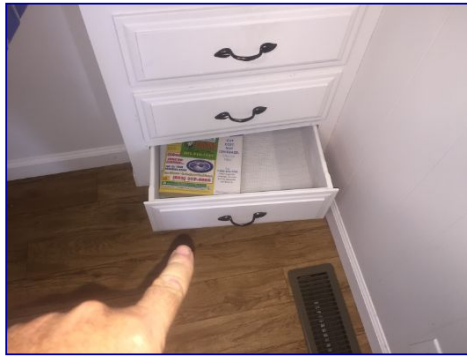
- The kitchen cabinet bottom drawer next to the dining room has broken drawer guides. Repair as needed.

The bottom kitchen cabinet drawer in the dining area has broken drawer guides.

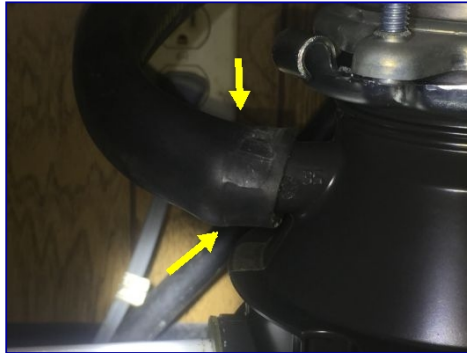
- The garbage disposal was missing a hose clamp for the dishwasher drain line. See photo.

The dishwasher drain line on the garbage disposal is missing a clamp.

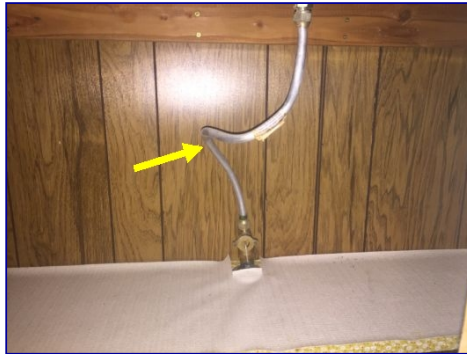
The kitchen cook top gas shutoff is under the cabinet. The fixed aluminum gas line should be replaced.

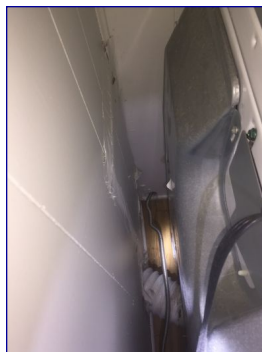
The laundry room gas dryer shutoff valve is outside in the furnace closet.

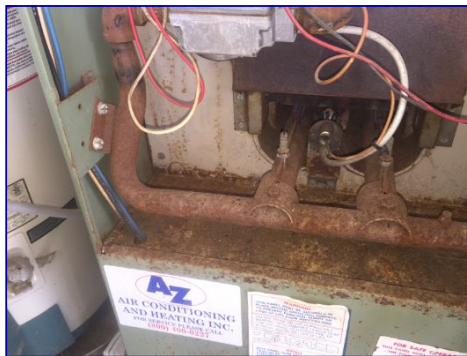
- The older furnace is original to the home and is heavily rusted and will begin to fail. Suggest replacing the furnace in the next few years.

The furnace is heavily rusted inside.

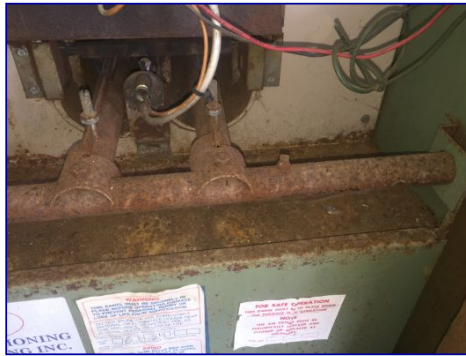
- The combustion chamber on the heater is heavily rusted.

The furnace is heavily rusted inside.

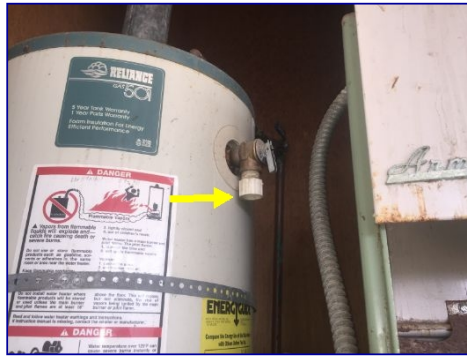
- **Water Heater: Missing temperature Pressure Relief Valve (TPRV) over flow line. An overflow line should be installed within six inches of the floor to prevent hot water from spraying on you, if the TPRV where to open. Suggest having a certified plumber make the proper repairs.**

The water heater should have a copper drain line pipe extended down to the catch pan.

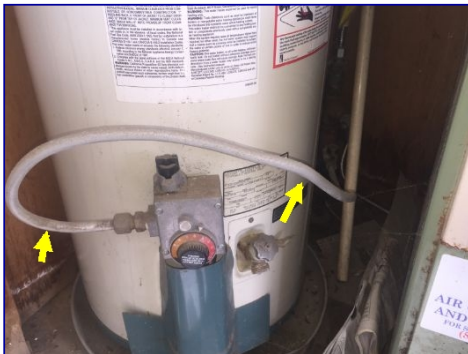
The water heater should not have a non flexible nor an aluminum gas pipe.

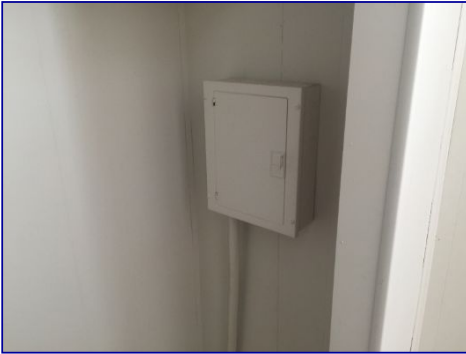
The home has a sub panel in the West side back bedroom closet.

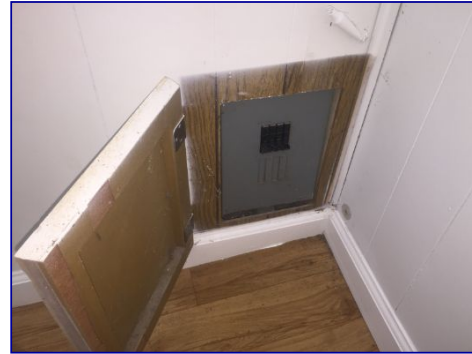
There is a second sub panel in the Master bedroom.

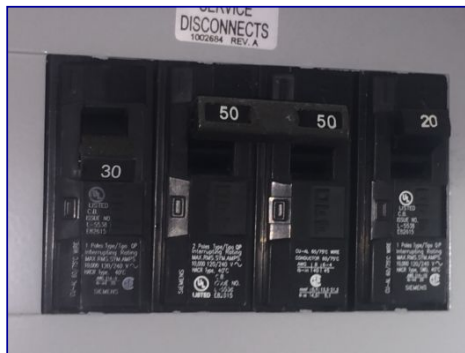
- The electrical service main is a maximum of 50 AMP's.

The home has a 50 AMP electrical service.

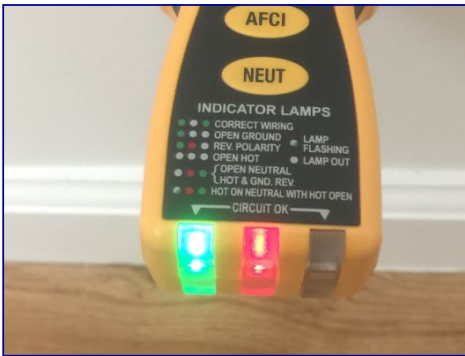
- There was an electrical receptacle in the Master bedroom (on the West wall) with no ground. A receptacle in the South side bedroom on the West wall had reversed neutral and hot wires. All electrical repairs should be made by a certified electrician.
- Extension cord used in lieu of "hard wire". The Master bedroom has an extension cord in an receptacle on the South wall that runs into the wall for a flat screen TV setup. A proper receptacle should be added.

The South side back bedroom has an electrical receptacle on the West wall with reversed neutral and hot.

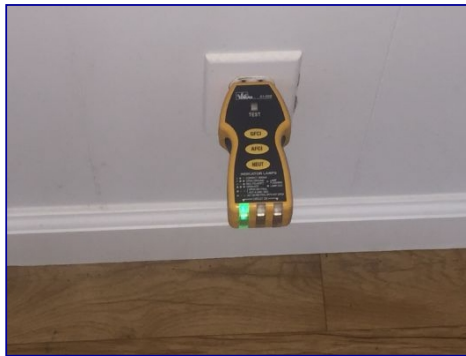
The Master bedroom has a receptacle on the West wall with no ground.

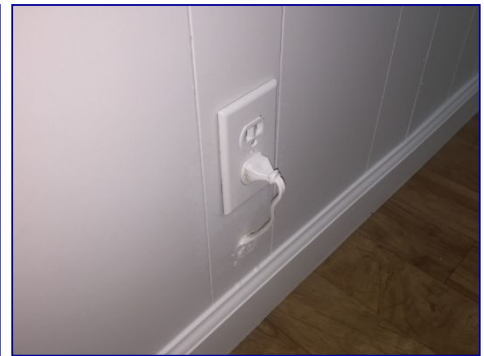
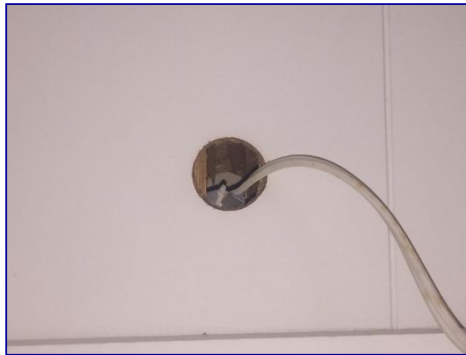
The Master bedroom has an extension cord plugged into a receptacle and running back into the wall for a wall hung TV.

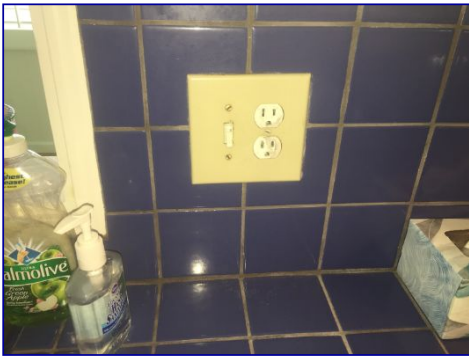
• **Concern:** There was no **GFCI** protection in the home at each needed location. Ground Fault Circuit Interrupter (GFCI) protection has been around since 1971, but became more common in 1987. Although GFCI protection may not have been required at the time the home was built, for safety reasons, consider upgrading the electrical system to include GFCI protection at the following locations:

The kitchen electrical is not GFCI protected.

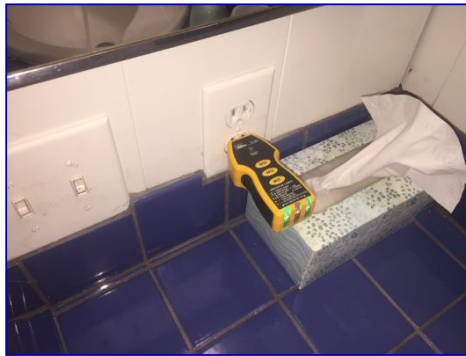
The bathrooms do not have GFCI protection.

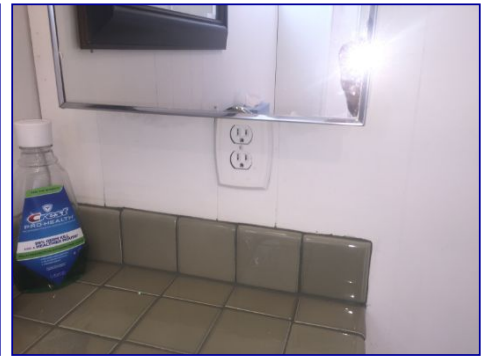
The Master bathroom has no GFCI protection.

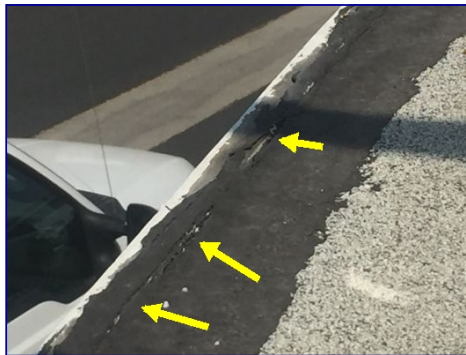
- The outer edges of the front and back roof have cracking mastic along the edge that needs to be replaced to prevent water intrusion.
- The front roof over the enclosed patio has a cactus plant growing on the roof edge. The plant needs to be removed before it causes damage to the roof.

The edges of the roof (front and back) need a new coating of roofing mastic.

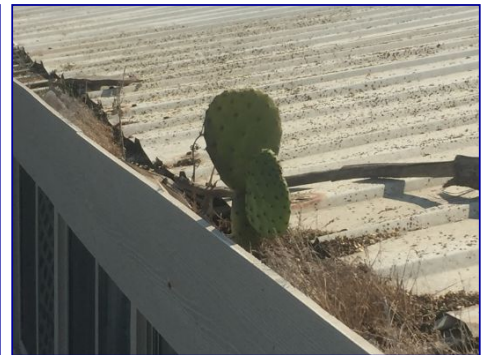
there is a cactus plant growing on the roof of the front enclosed porch.

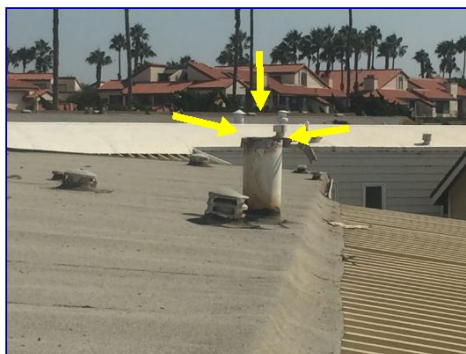
- The roof furnace exhaust vent is missing a cap. The cap needs to be added to prevent water from entering the furnace when it rains.

The furnace exhaust pipe on the roof is missing a cap.

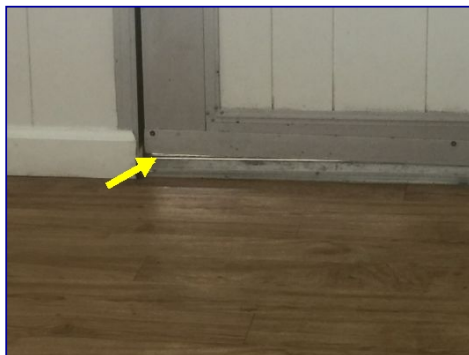
- Exterior door on the enclosed patio needs a weather seal on the bottom edges of the door. The lack of a threshold and/or weather strip on the door will allow water to enter the home and cause damage to the home's structure. Suggest making the proper repairs.

The exterior back porch door needs a new weather strip.

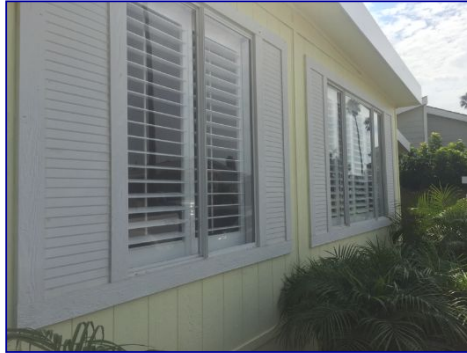
- The front living room and South side bedroom windows on the home were missing window screens at the time of the inspection. Suggest screen replacements to keep bugs and pest on the exterior.

The front and West side bedroom windows are missing screens.

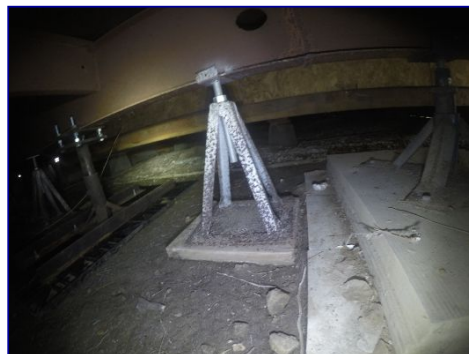
The 12 foot metal jacks under the home are covered with surface rust and should be monitored.

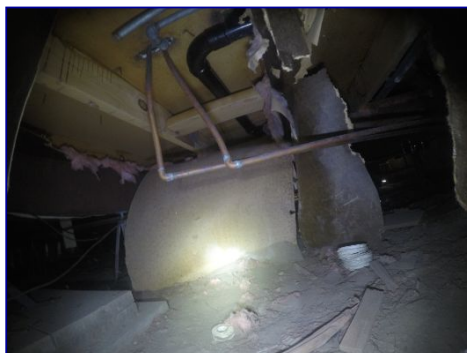
- **Some crawlspace areas of installed insulation and the protective belly cover of the home had been opened up and insulation removed to make possible plumbing repairs. Suggest adding new insulation and sealing belly cover backup.**

Some protective covering and insulated areas have been opened up under the home for possible plumbing repairs.
